FIRE SAFETY OF MASS TIMBER BUILDINGS WITH CLT IN USA

Abstract. Multistory buildings using mass timber and cross-laminated timber (CLT) as the primary structural elements are being planned and constructed globally, with interest starting to gather momentum in the United States. Model building codes in the United States limit timber construction to a building height of 85 ft (25.9 m) because of concerns over fire safety and structural performance. Up to 85 ft, the mass timber can be exposed. Architects and developers in the United States are pushing boundaries, requesting mass timber structures are constructed as high-rises and that load-bearing mass timber such as CLT be exposed and not fully protected. This provides an opportunity for the application of recent fire research and fire testing on exposed CLT to be applied, and existing methods of analyzing the impact of fire on engineered timber structures to be developed further. Fire testing has shown that exposing large areas of CLT significantly impacts the heat release rate and fire duration. This article provides an overview of the code requirements for timber construction in the United States, provides methods for building app

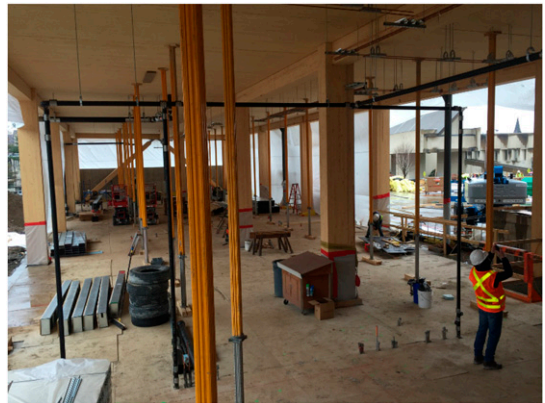
Figure 1. Type IV building under construction, using cross-laminated timber as part of the primary structure (image, Arup).

Within the United States, buildings up to 85 ft are permitted by the IBC to have all the load-bearing timber structure fully exposed (see Fig 1). Thus, CLT used for floors or walls can be exposed where the local jurisdiction adopts the 2015 IBC, and the building meets the height and area limitations of the code and the detailed requirements of Type IV construction. A Type IV building of up to 85 ft will include automatic fire detection, sprinkler protection, and two fire-protected egress stairs. It will also have the first floor constructed from concrete construction, meeting Type IA (3 h fire ratings).

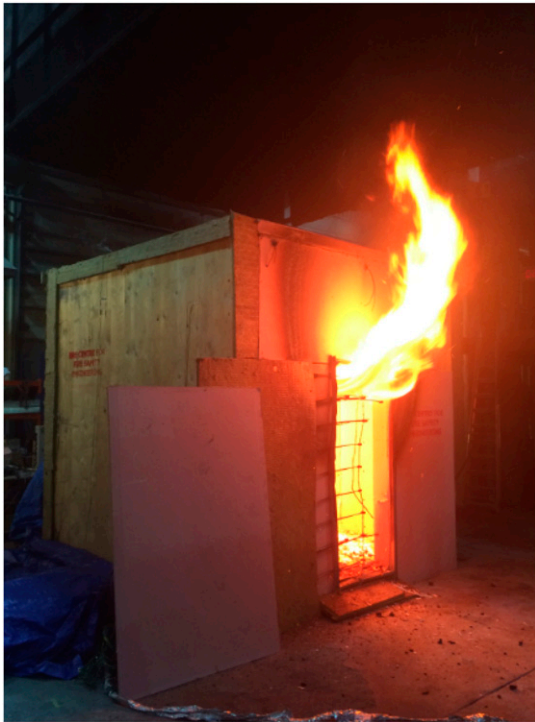
Figure 2. Exposed cross-laminated timber compartment fire test undertaken at BRE by the University of Edinburgh and Arup (image, Arup).

There has been a number of full-size fire tests of rooms with exposed CLT panels (walls or underside of floor) in Canada, Europe, UK (see Fig 2), Australia, and United States (Frangi et al 2008; Wilinder 2010; Craft et al 2011; Aguanno 2013; McGregor 2013; Medina 2014; Hox et al 2015; Kimball et al 2017; Emberley et al 2017; Hadden et al 2017). The aim of the fire testing has

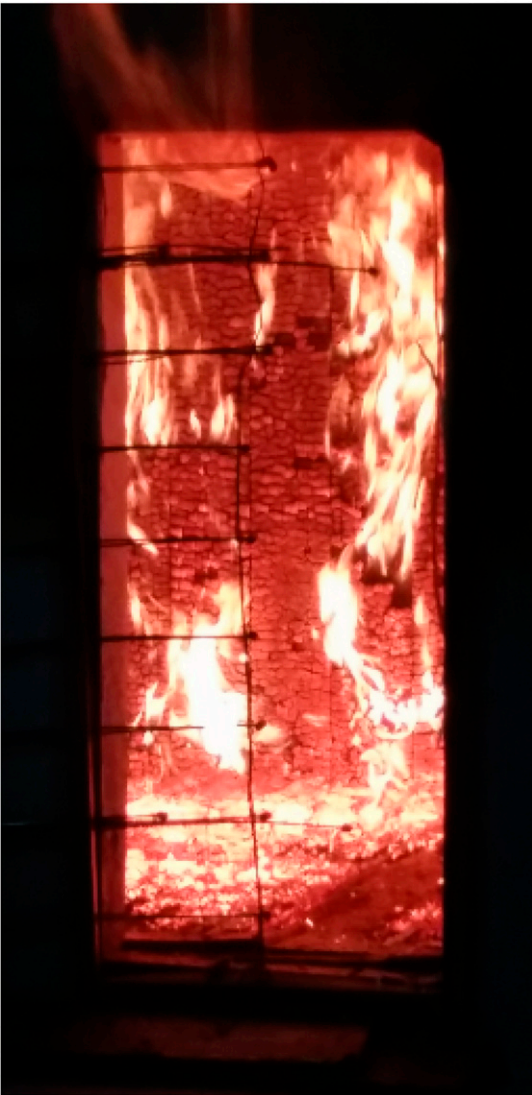
Figure 3. Cross-laminated timber with delamination occurring at ply interface (dark areas on wall) during fire test (image, Arup).

The fire testing has also shown the impact of CLT that is susceptible to premature failure of the plies at the adhesive interface, before complete charring through the adhesive line occurs. This has been referred to as delamination, char fall off, de-bonding, or stickability (Klippel et al 2016). The term delamination will be used in this document. Delamination is the process in CLT where small pieces of mostly charred CLT separate from the unburnt CLT base as the charring reaches the ply interface. The separation of the

char occurs because of the ply adhesive softening under increased temperatures (see Fig 3).

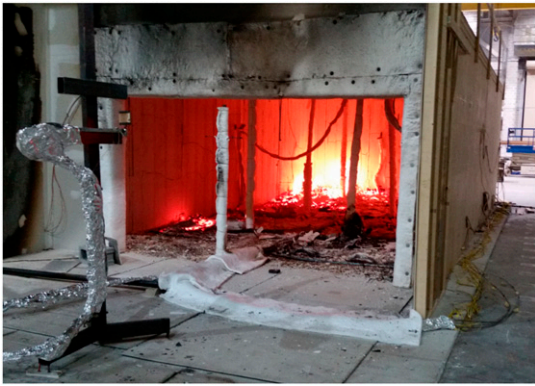
Figure 4. Fire Protection Research Foundation fire Test 2, near completion at 100 min after ignition (image, Arup).

Test 2. The compartment was fully protected to all surfaces with two layers of Type X plasterboard, with larger wall opening. Flashover occurred in 15.3 min with a peak HRR of 12.5 MW. This test had a larger opening and hence different HRR. The test was terminated at 104 min after continuous fire decay with the HRR falling less than 500 kW.

Most of the base layer plasterboard remained on the ceiling whereas some pieces were lost in the middle section of the ceiling. The face layer of the plasterboard fell off the ceiling from 36 to 40 min. All two layers of plasterboard remained on the walls at the end of the test. There was some evidence of charring on the ceiling.

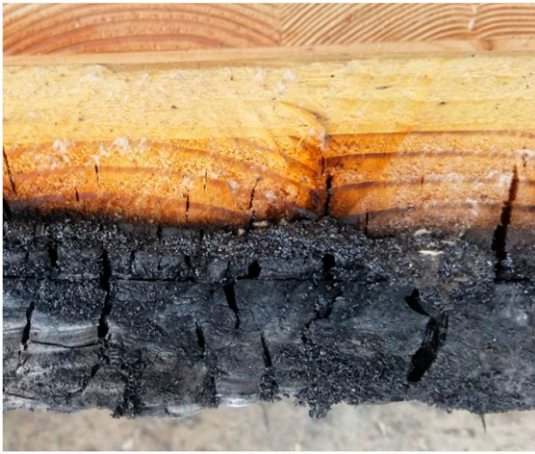
Figure 8. Cut section through five-ply cross-laminated timber floor panel, successfully passing a fire test to ASTM E119 to 2 h, without any delamination occurring (image, Arup).

Given the desire by architects and building owners to have more timber exposed in their buildings, it is expected that future codes or manufacturing standards may require CLT to be produced to not delaminate (see Fig 8).
